Geological Society of America
 Special Paper 375
 2004

Seismic vulnerability of the healthcare system in El Salvador and recovery after the 2001 earthquakes

Ruben L. Boroschek*

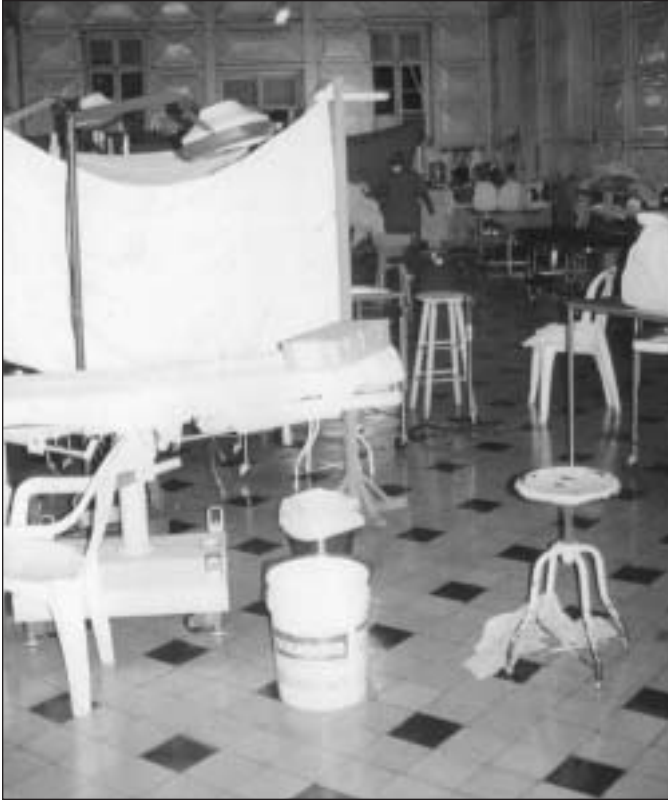
Figure 5. Temporary surgical rooms in Rosales Hospital.

Due to the evacuation of the most important hospitals, health care was performed outdoors. The operation required a large number of tents and temporary housing that was organized in the vicinity of existing structures (Figs. 5, 6, and 13).

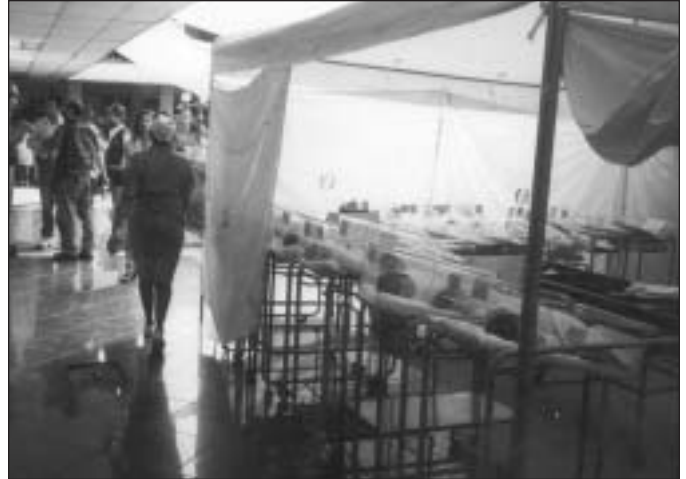
Figure 6. Neonatology in outside shelter structure. 1° Mayo Hospital.

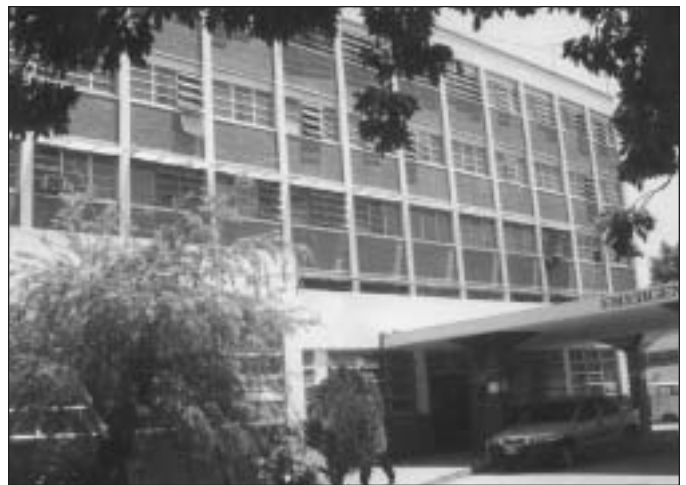
Figure 7. Typical structural system based on frame and infilled wall system.

The structural damage observed can be classified as severe for structures with low seismic capacity, such as adobe construction (San Rafael Hospital and others). In general, the main hospitals structured with moment resisting frames and frame-wall buildings suffered relative minor to moderate structural damage and no collapse (Fig. 7). On the other hand, nonstructural damage was generalized and severe. A visit to the main hospitals of the country indicated a complete absence of seismic design for architectural elements, medical and industrial equipment, and distribution systems such as piping, ducts, etc. Because of the severity of the earthquake and the relatively small size of the country, most of the hospitals in the coastal and central areas

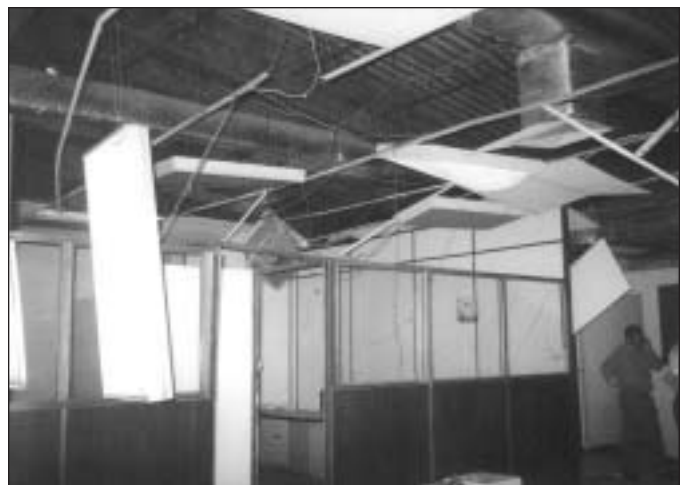
1. Severe damage and collapse of suspended ceilings and lighting fixtures (Fig. 8) due to absence of restraints, inadequate use of railings and supporting systems, and lack of structural expansion joints.

4. Severe damage to piping and ductwork due to lack of restraints, no consideration for structural expansion joints, and poor maintenance, shown previously in Figure 8.

Figure 8. Damage to suspended ceiling, lighting fixtures, and air conditioning. Fertility building in Maternity Hospital.

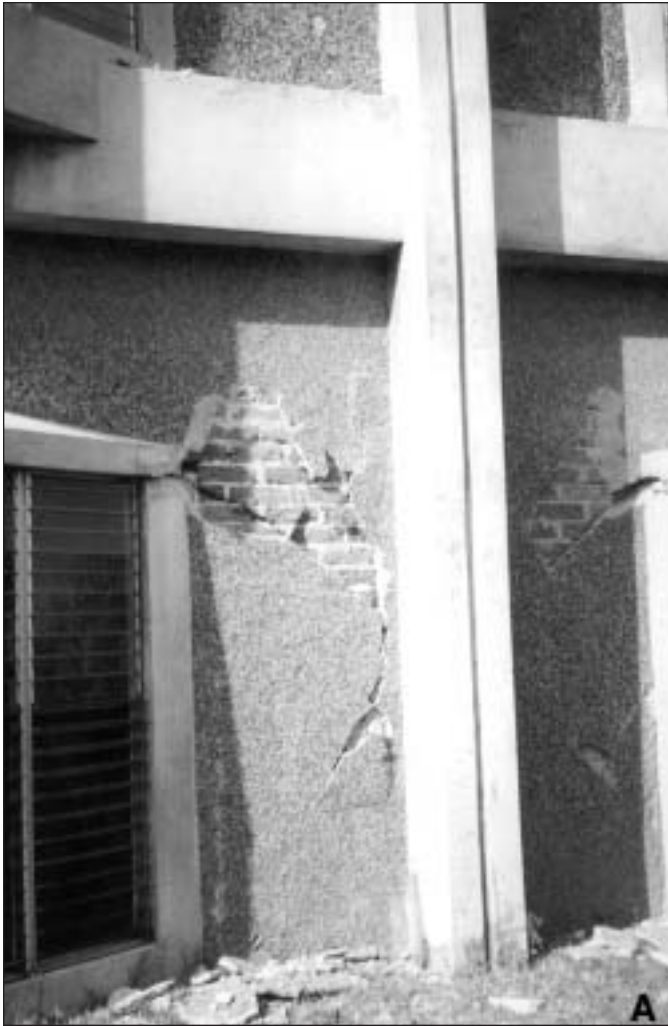
2. Severe damage and collapse of infilled walls and facades (Fig. 9) due to lack of expansion joints, inadequate expansion joints, and inadequate out-of-plane support.

Figure 9. Damage to partition and facades due to inadequate isolation. San Rafael Hospital.

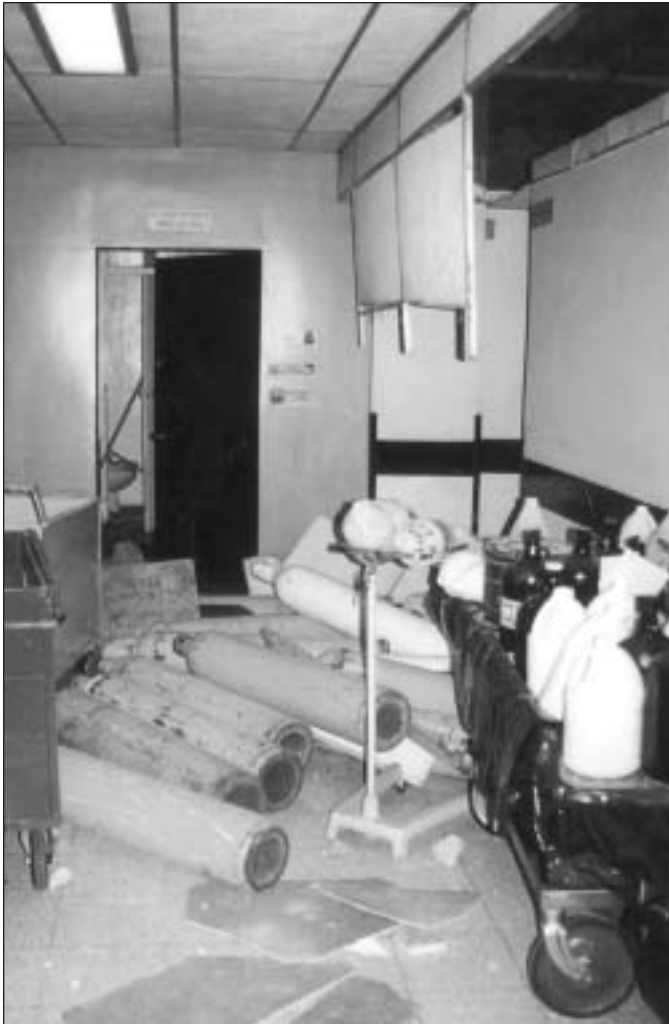
5. Severe damage to medical equipment and supplies due to inadequate furniture and supports (Fig. 11).

Figure 11. Medical equipment and supply damage. Surgery Building, Rosales Hospital.

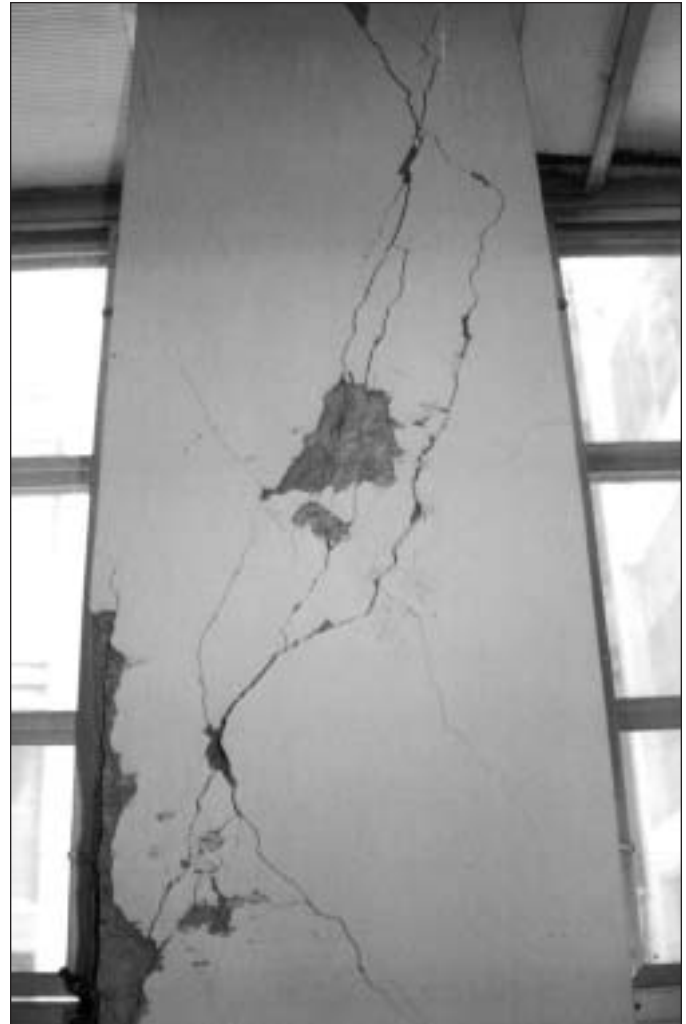
On February 13th, the second strong earthquake occurred. This event increased the fear of the population and caused damages in the Zacatecoluca, Santa Gertrudis of San Vicente, and Cojutepeque hospitals (Tables 1 and 2; Fig. 12).

Figure 12. Shear failure in column due the presence of partial-height infilled walls. Zacatecoluca Hospital.

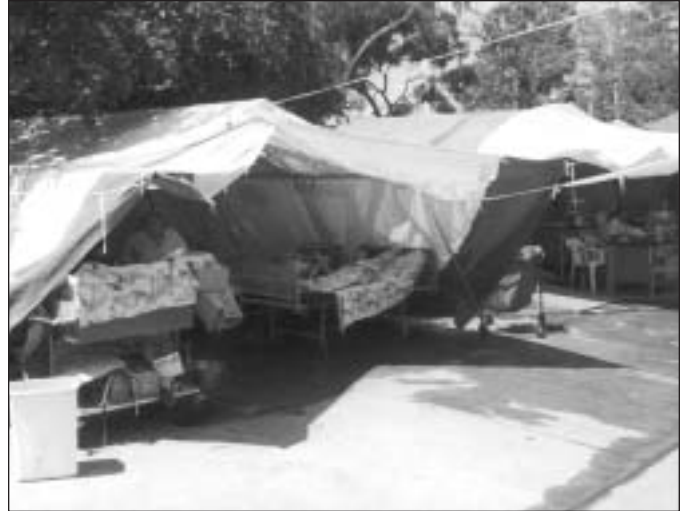
Figure 13. Temporary shelters for long-term patients.
